Manhole Inspection Summary

Manhole # S27M__028MH

Insp Date: **5/2/08 10:21 AM**

Location Address: **1184 W Ostend rd**

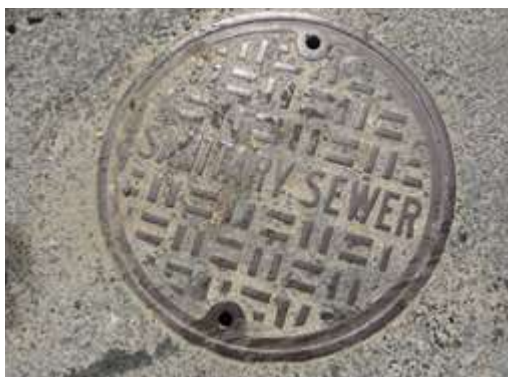
Cover View

Type: **Sanitary** Condition: **Sound** Cover Material: **Cast Iron**

Frame Offset: **0** (in.) Condition: ☐ Sound ☐ Cracked ☒ **Leaks**

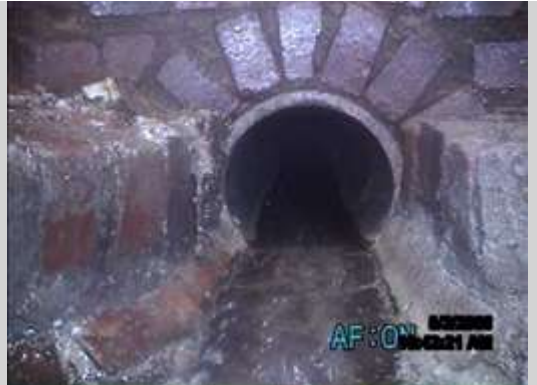
12 O'Clock Outflow

8 in. Circular Gravity Sewer
Pipe Out @ 12 O'Clock

Pipe Height: **8.4** (in.) Rod and Bar (Angled)
Pipe Material: **Clay** ☐ Pipe Lined
Invert Depth: **9.49** (ft.) Flow Characteristics: **Slow**
Deposits: ☒ None ☐ Mud ☐ Sludge ☐ Debris ☐ Grease
Silt Depth: **0** (in.) Deposits Extent:
Infiltration: **None** Pipe Seal Cond: **Sound**

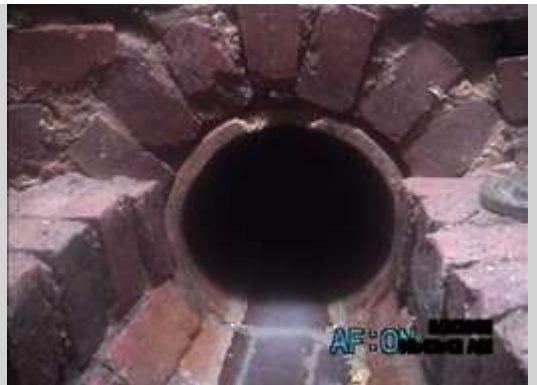
3 O'Clock Inflow

8 in. Circular Gravity Sewer
Pipe In @ 3 O'Clock

Pipe Height: **8.4** (in.) Rod and Bar (Angled)
Pipe Material: **Clay** ☐ Pipe Lined
Invert Depth: **9.26** (ft.) Flow Characteristics: **Slow**
Deposits: ☒ None ☐ Mud ☐ Sludge ☐ Debris ☐ Grease
Silt Depth: **0** (in.) Deposits Extent:
Infiltration: **None** Pipe Seal Cond: **Sound**

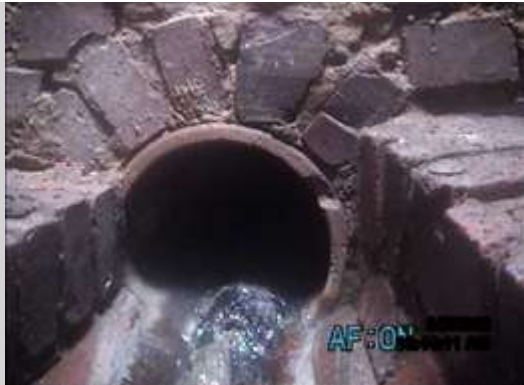
6 O'Clock Inflow

6 in. Circular Gravity Sewer

Pipe In @ 6 O'Clock

Pipe Height: **9.6** (in.) Rod and Bar (Angled)

Pipe Material: **Clay** ☐ Pipe Lined

Infiltration: **None** Pipe Seal Cond: **Sound**
